# SkyPoint LLC – Roof Condition Summary

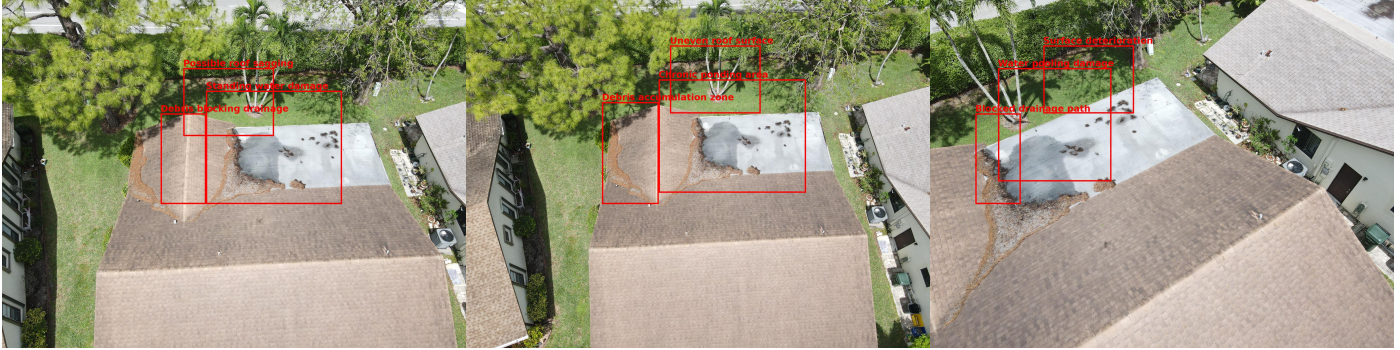
- Standing water observed on flat roof section
- Debris accumulation blocking drainage paths
- Uneven surface indicating possible roof sagging
- Localized surface deterioration on flat membrane
- Shingle roof shows general aging

The flat roof section is exhibiting signs of chronic ponding, which typically indicates poor drainage or underlying structural sagging. This condition increases the likelihood of membrane failure and interior water intrusion over time. The shingle roof appears aged but not currently failing.

Recommend evaluation by a licensed roofing contractor. Repairs may include drainage correction or flat roof resurfacing; in some cases, partial replacement may be required. Routine debris removal is advised to prevent further water retention.
